# Service bulletin concerning corrosion to pre-2019 VZ jib

DOCUMENT NUMBER 1035377

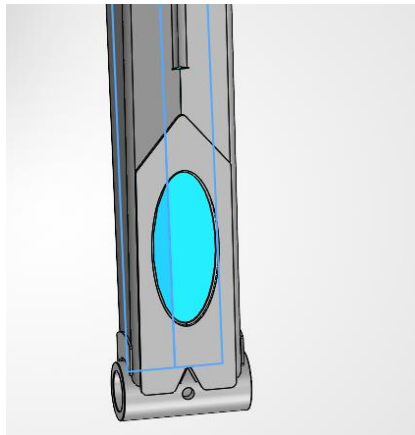
Two cases of severe corrosion have been reported in VZ machines manufactured in 2015 and 2016. The corrosion has occurred on the inside of the lower face of the jib. This area should therefore be checked carefully with cases of significant corrosion being investigated further. The faces highlighted in blue show the area of concern.

In 2019, this design was changed to include a large elliptical hole in the lower face, as well as the upper face. Post 2019 models are therefore less susceptible to corrosion in this area because of the greater thickness of structural material.

Pre-operation checks should always include checks for deterioration, but operators are asked to focus on this particular area, and report any concern. If water has been collecting in this area, the remaining thickness of the steel on the lower face of the jib should be checked. Contact Aldercote for assistance if necessary.
