# Service bulletin concerning fatigued manifold block bolts

DOCUMENT NUMBER 1035207

Document Summary
Bolt fatigue on cylinder manifolds

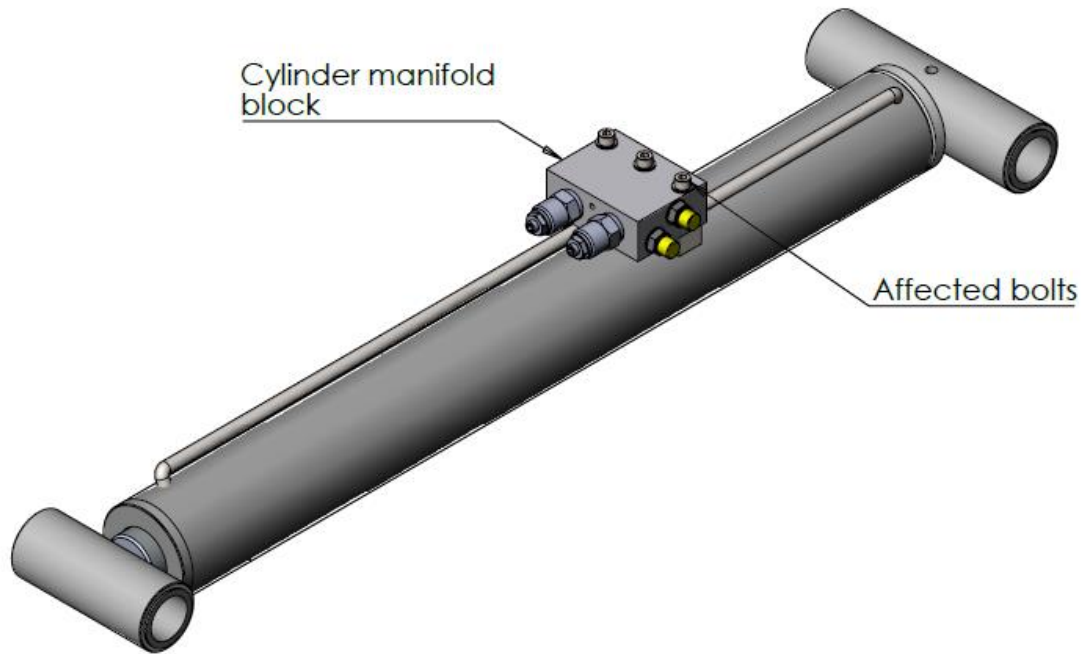
Two cases have just been reported of fatigue occurring on the bolts which hold the manifold blocks onto the jib (upper boom) cylinders. As shown in Figure 1, below:

Figure 1 cylinder showing the affected bolts

All V, VZ, VX and VZX systems which have been in service since 2016, must be checked, this means any system with a serial number greater than 13417.

If any damaged bolts are found, the owner / operator must remove the platform from service immediately, and contact Aldercote, to arrange a repair.

If all bolts are found to be in good condition, the system can continue in use, but the bolts should be checked as part of the routine daily checks.

The bolts on the jib, main boom and lower boom cylinders should be replaced at the next LOLER inspection. Aldercote will provide the necessary bolts free of charge. Please contact the service manager to request the bolts required for your system.

When fitted, the bolts must be torqued to no more than 10Nm. A medium strength thread locking adhesive should be used.

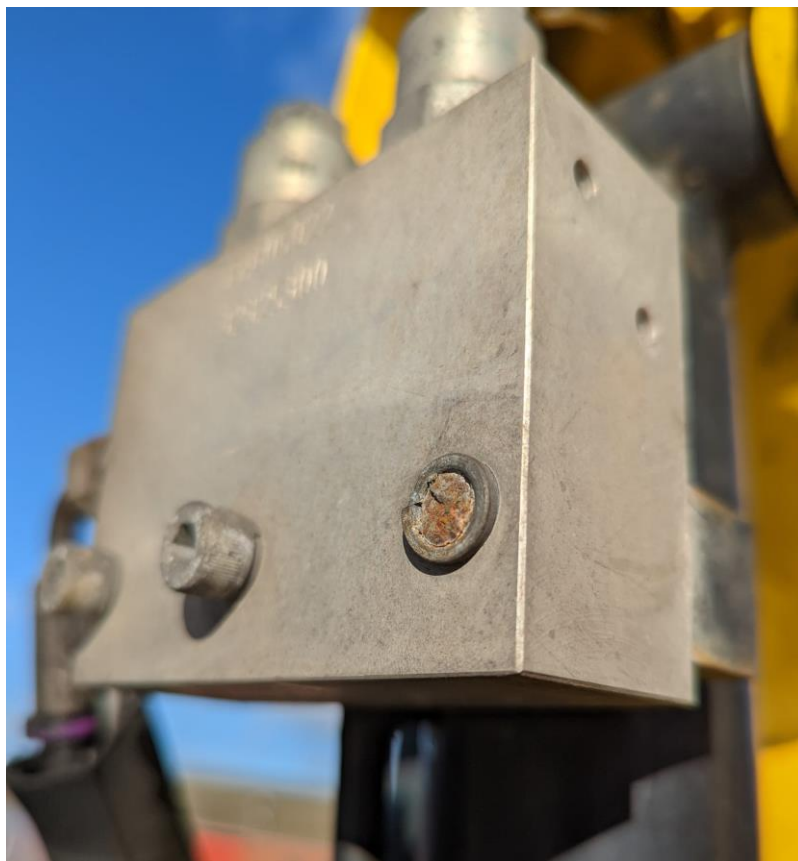
Figure 2 Failed bolt

In both cases one of the bolts had fatigued and the bolt head was lost. There has been no immediate risk of health and safety incidents, as each manifold is secured with three bolts, and the remaining bolts in both cases appeared to be in good condition. Nevertheless, any deterioration in the connection between the manifold block and the cylinder is serious, as total failure would lead to the uncontrolled descent of the booms.

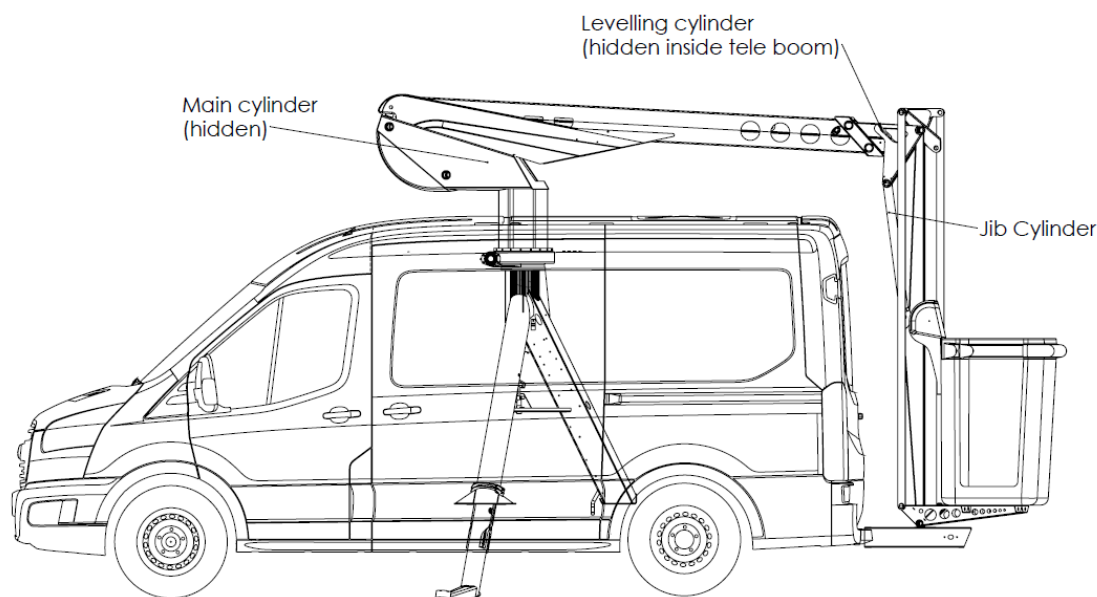
Manifolds are fitted in this way to the main boom cylinder, jib cylinder, levelling cylinder (VZ, and VZX only) and the lower boom cylinder (VZX and VX only) as illustrated below.

Figure 2 Cylinders affected by the possible defect
