Service bulletin VZ

DOCUMENT NUMBER 1035129

Description of observed stress crack on a van type jibs

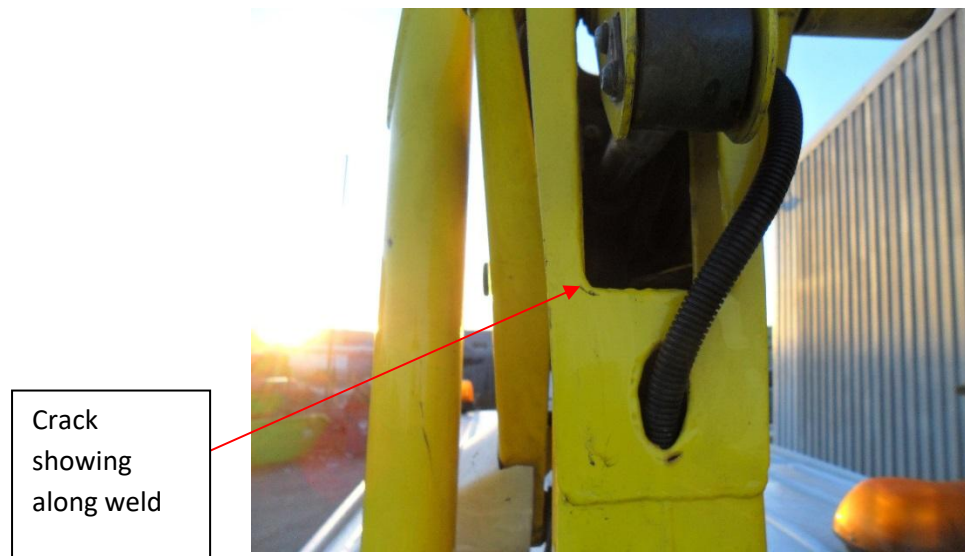
A service bulleting was issued in December 2017 regarding a possible stress crack on the forked end of the jibs of Aldercote van mounted platforms, as shown below: At the time all owners were requested to ensure that this area was checked carefully at every LOLER inspection, and to notify Aldercote if there was any sign of deterioration.

The recent remounting of 7 year-old platforms has revealed that there is a tendency for this component to develop stress cracks in the area shown, and on the under-side of the jib at the same point. It is critical that all platforms which were manufactured prior to 2018, be inspected carefully on both front and rear faces of the jib. If there are fatigue cracks developing in this area, the platform must be removed from service and repaired.

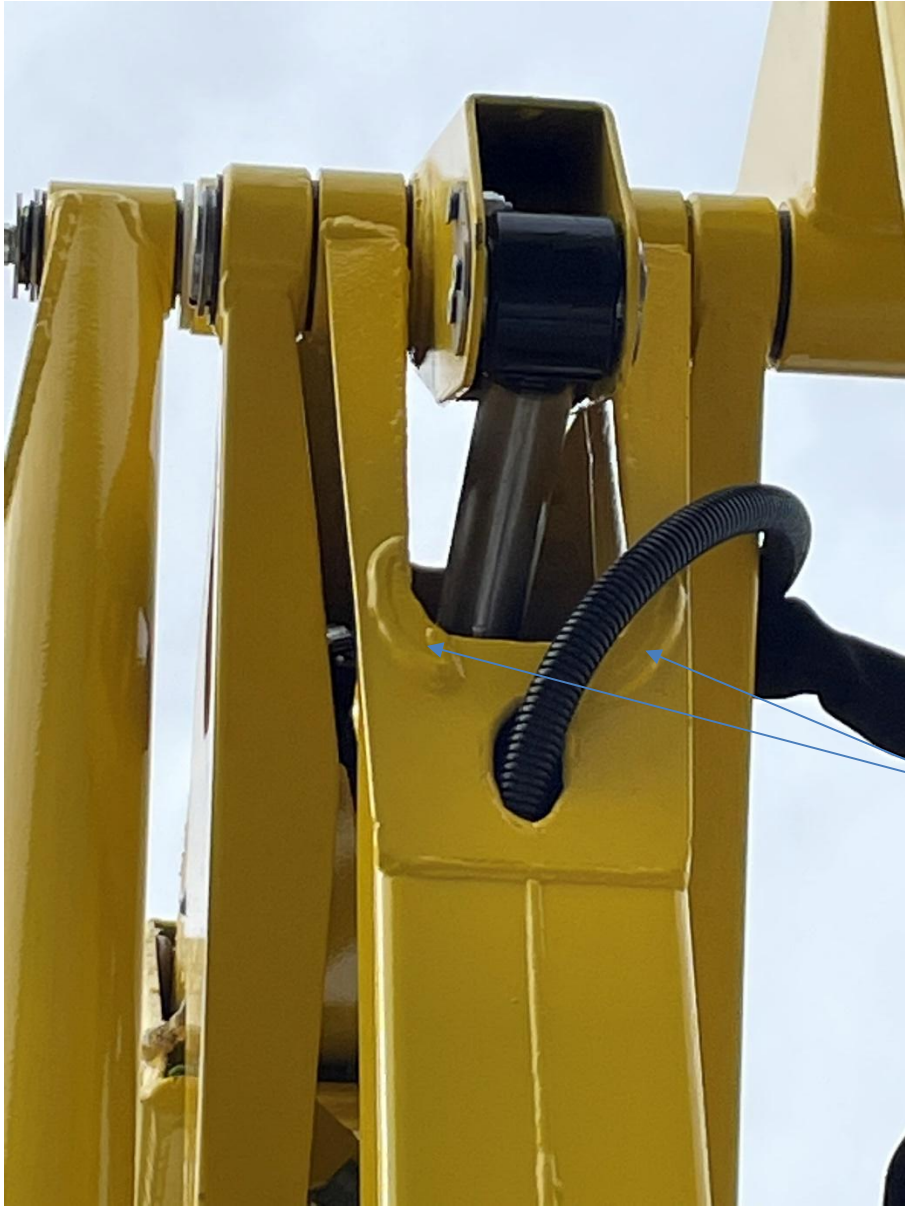
For the avoidance of doubt, if the forked end of the jib boom has the reinforcements in the affected area, as shown in the photograph below, no action is necessary. If this reinforcement is not present, the structure must be inspected.

Reinforcement
present
